**DYNAMIC SCIENCE, INC.**  
**In-Depth Accident Investigation**

**Contract Number DTNH22-94-D-27058**  
**Case Number DSI-94-AB-15**

## TECHNICAL SUMMARY

[REDACTED]  
This single vehicle crash occurred on a four-lane, divided, asphalt paved, rural road in [REDACTED] Maryland during the early morning hours of a summer weekday ([REDACTED] 94).

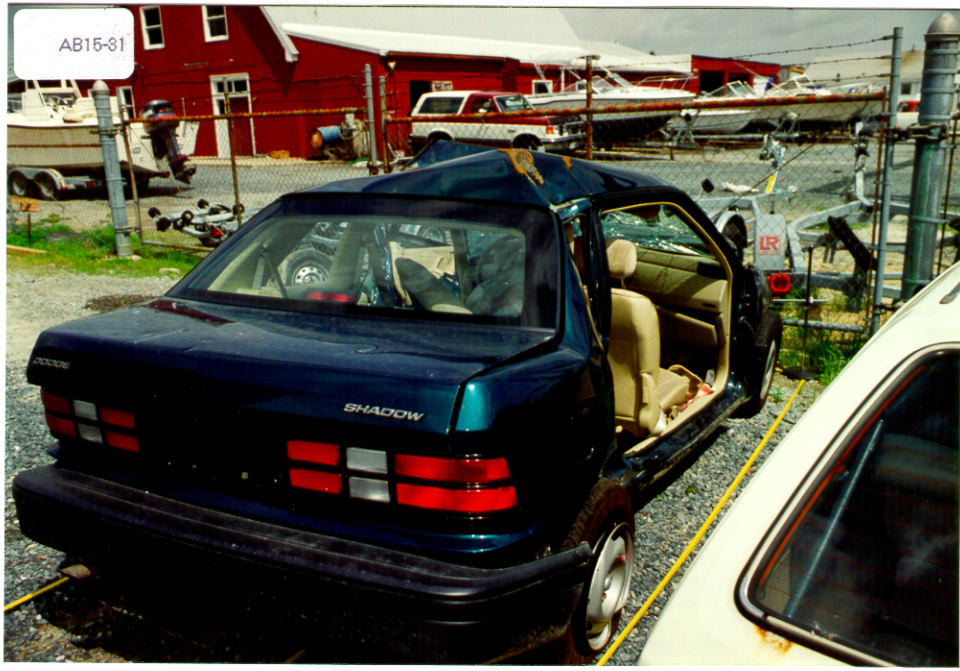
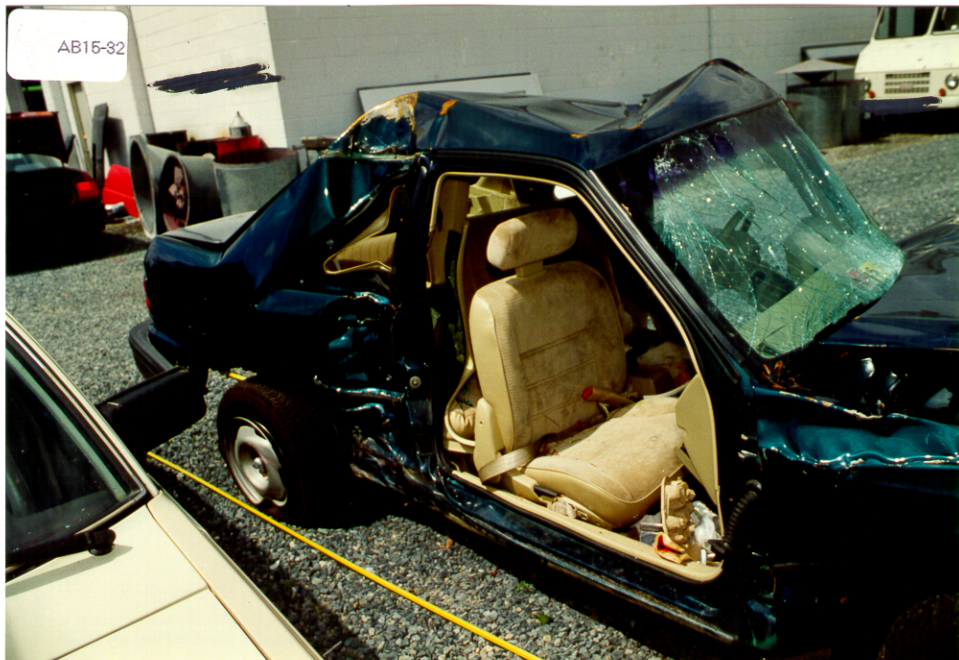
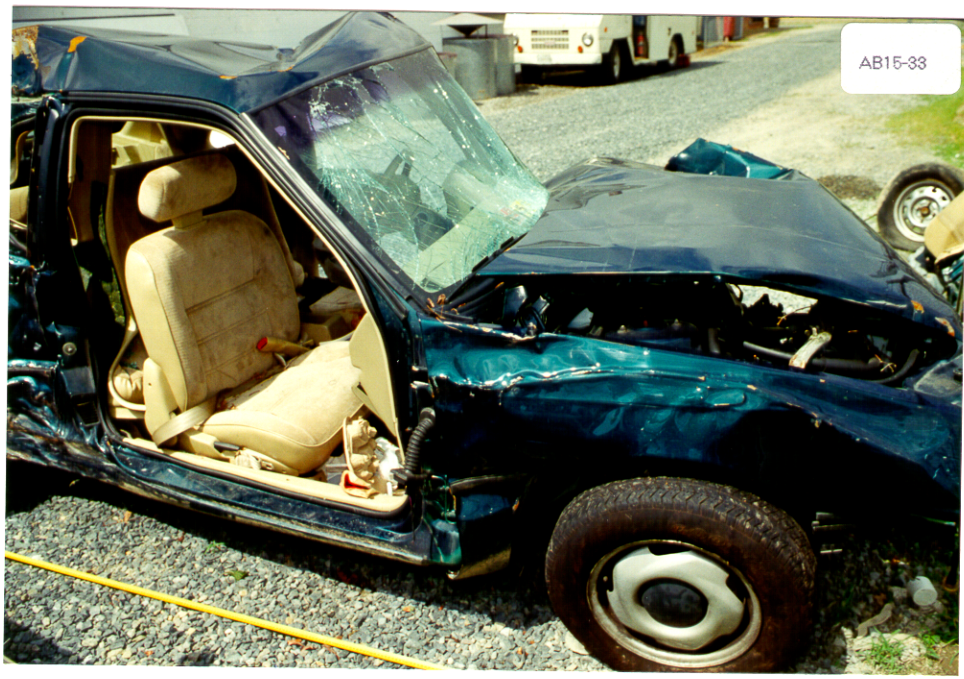
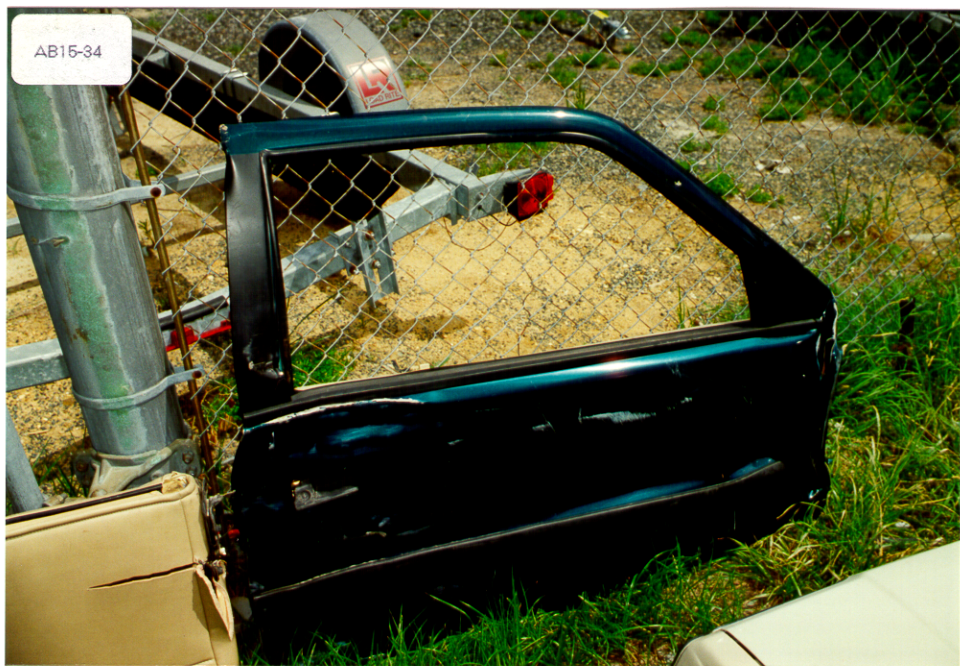
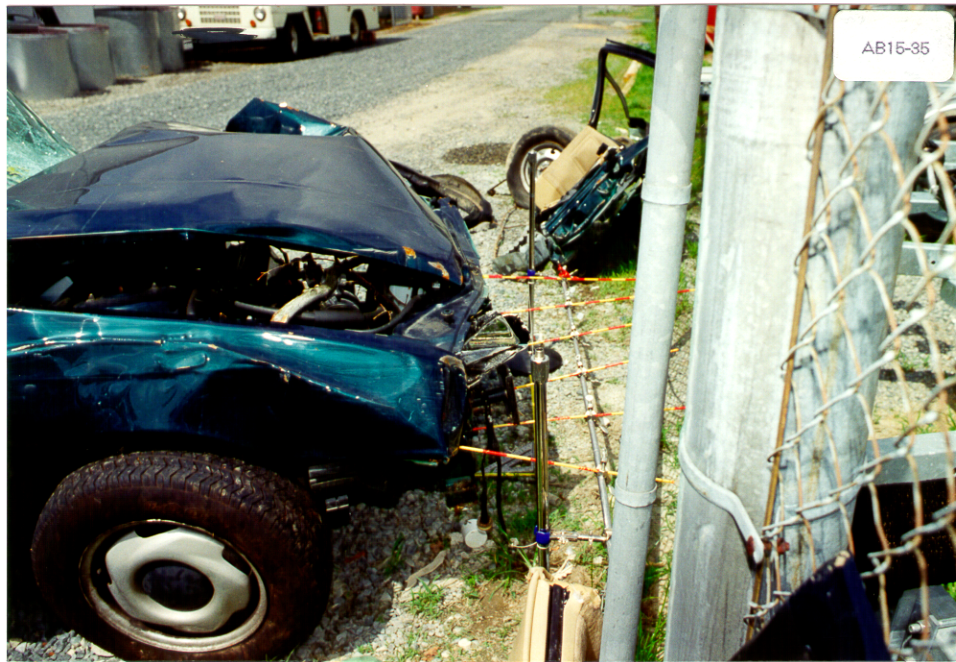
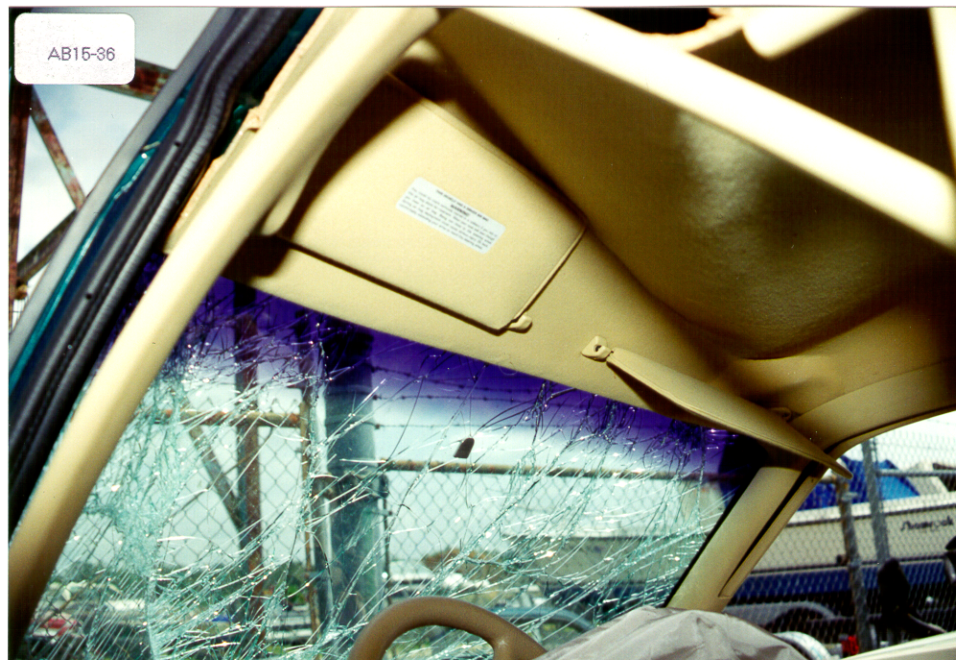
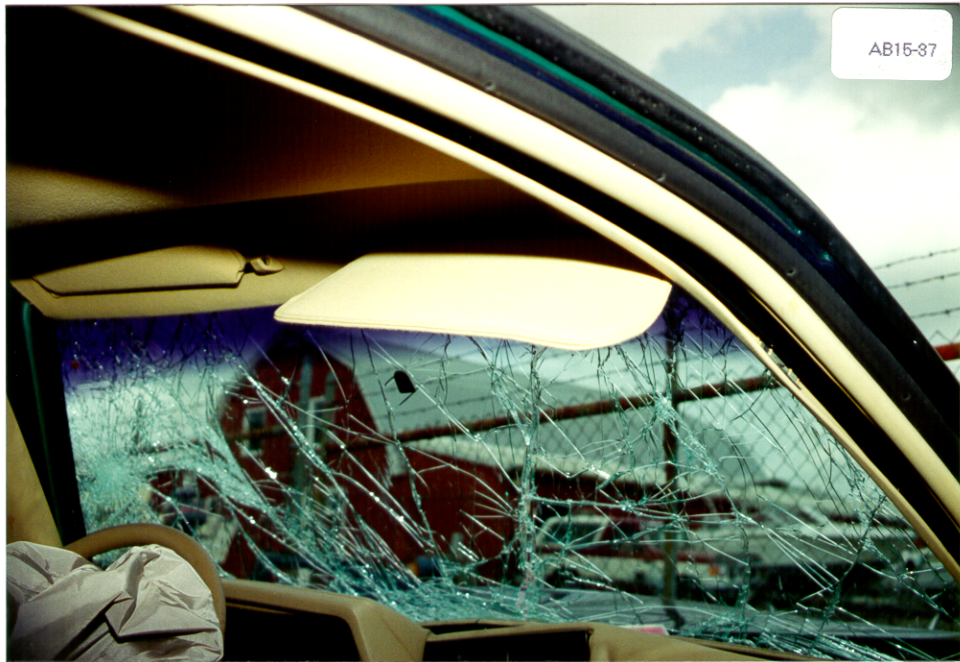
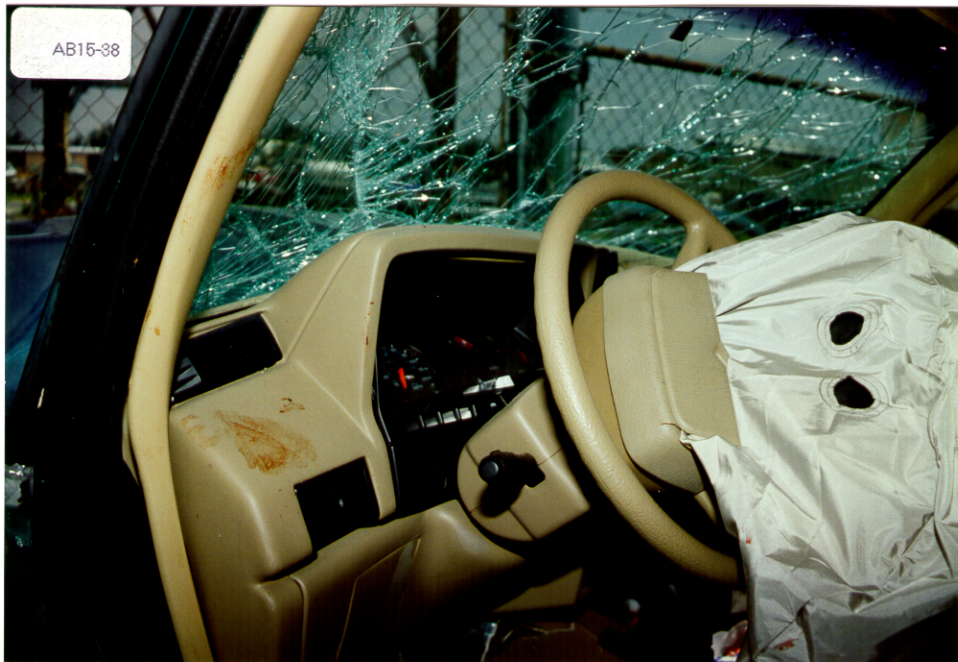
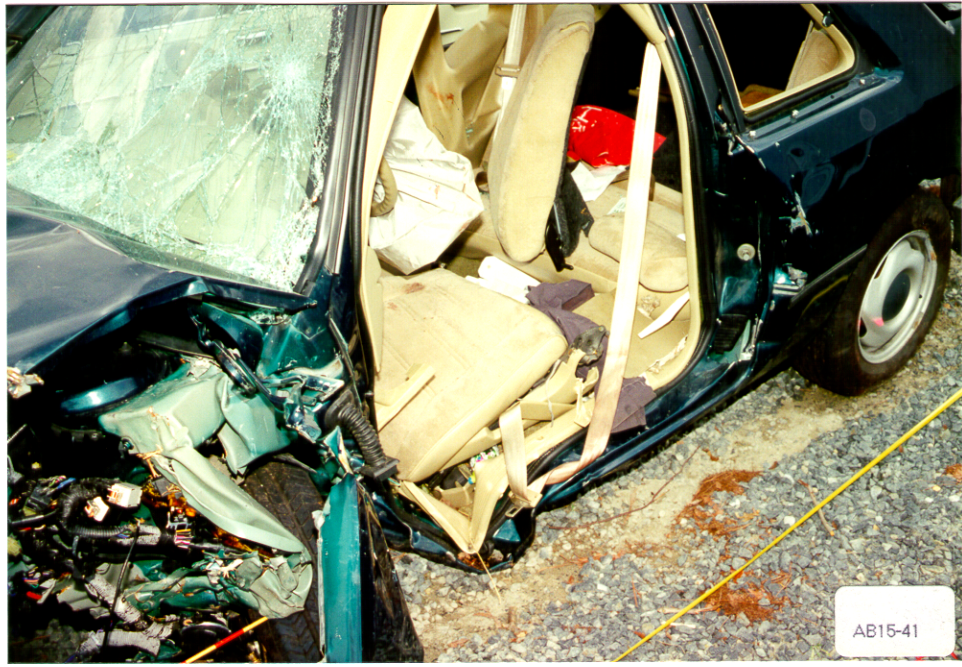
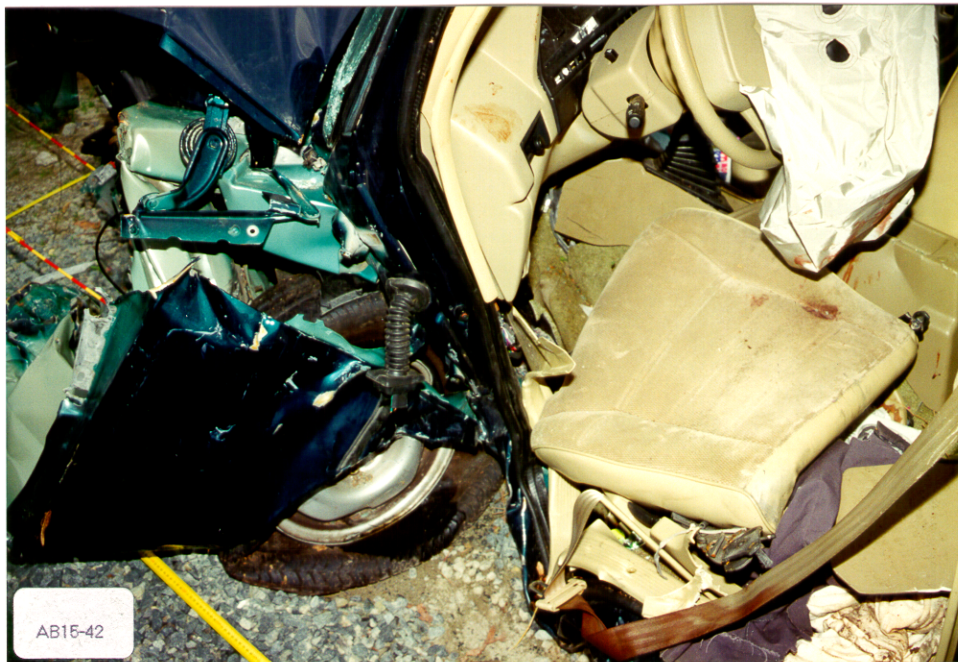
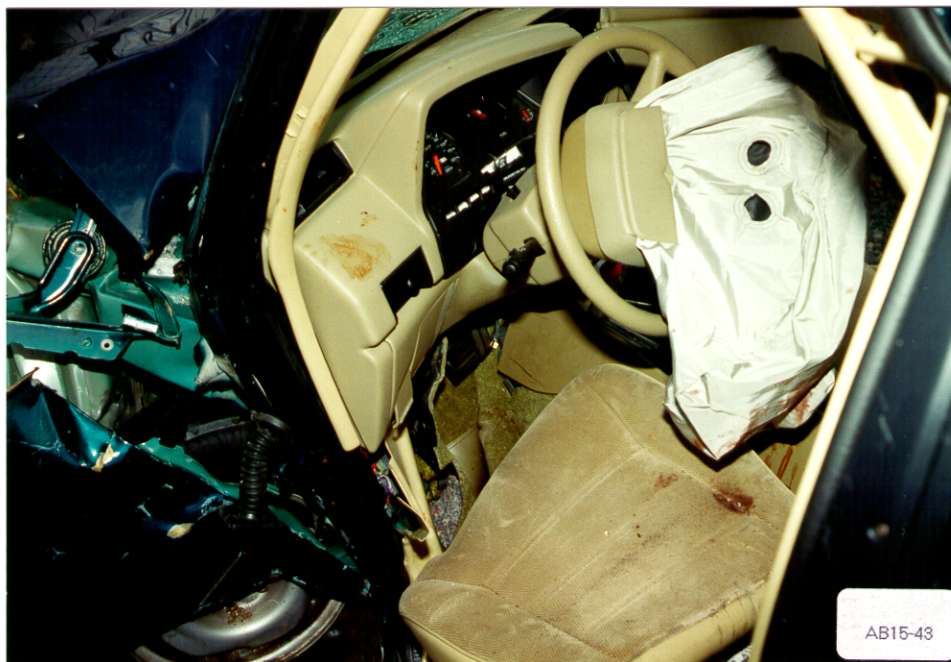
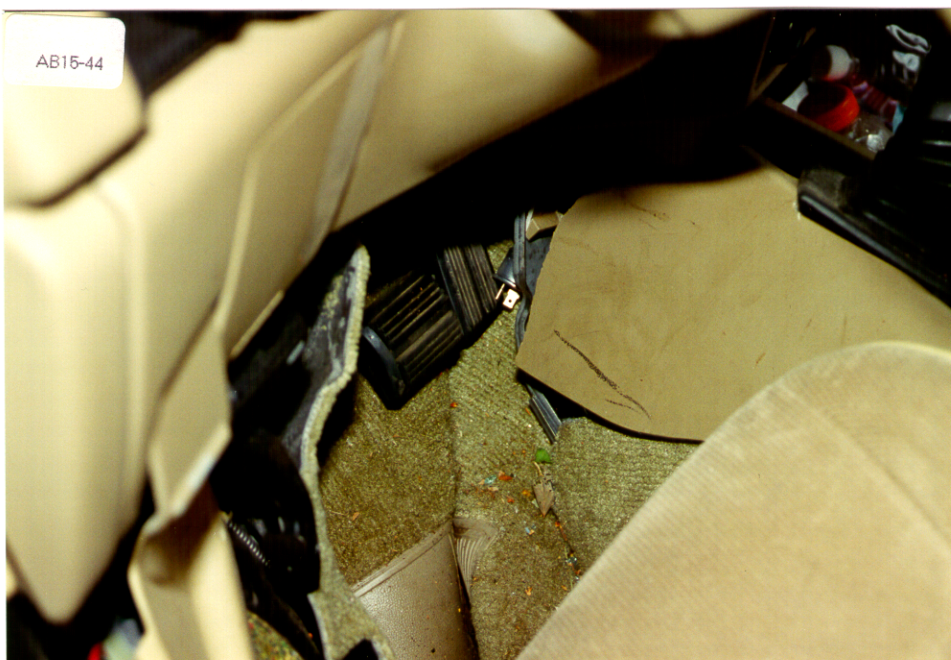
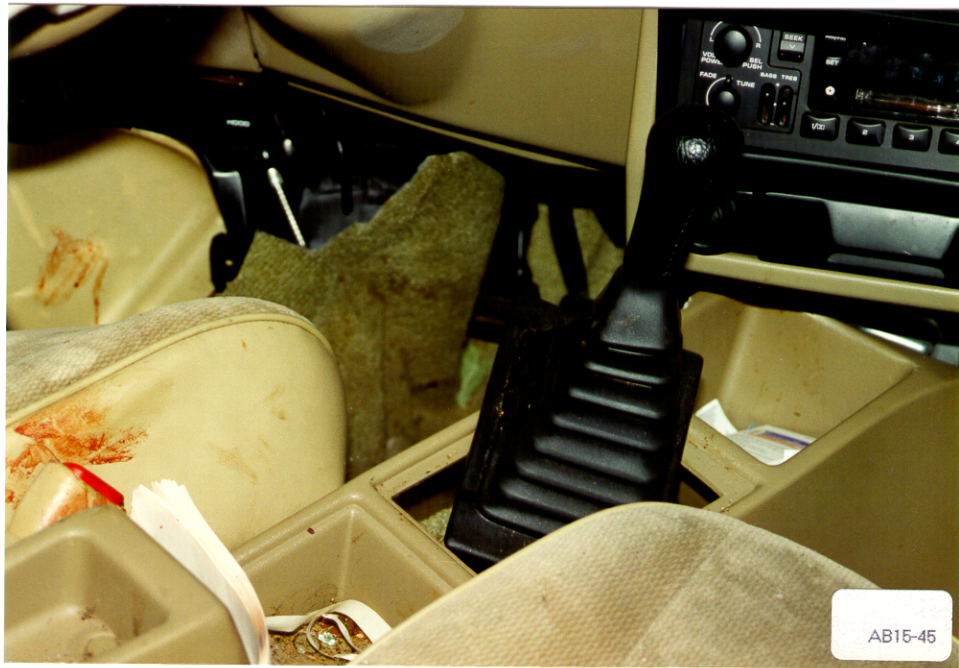
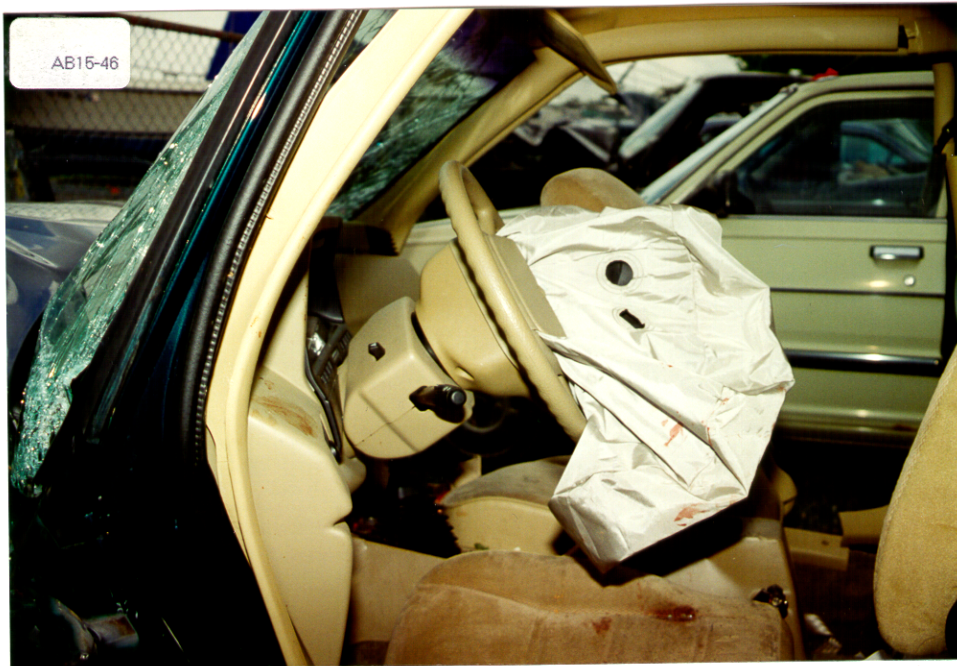
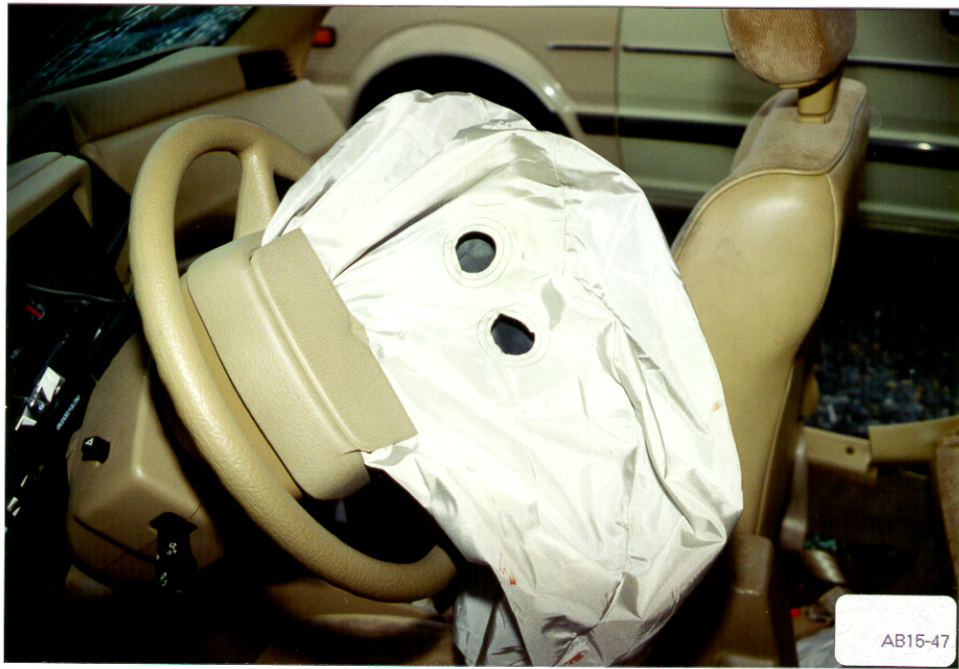
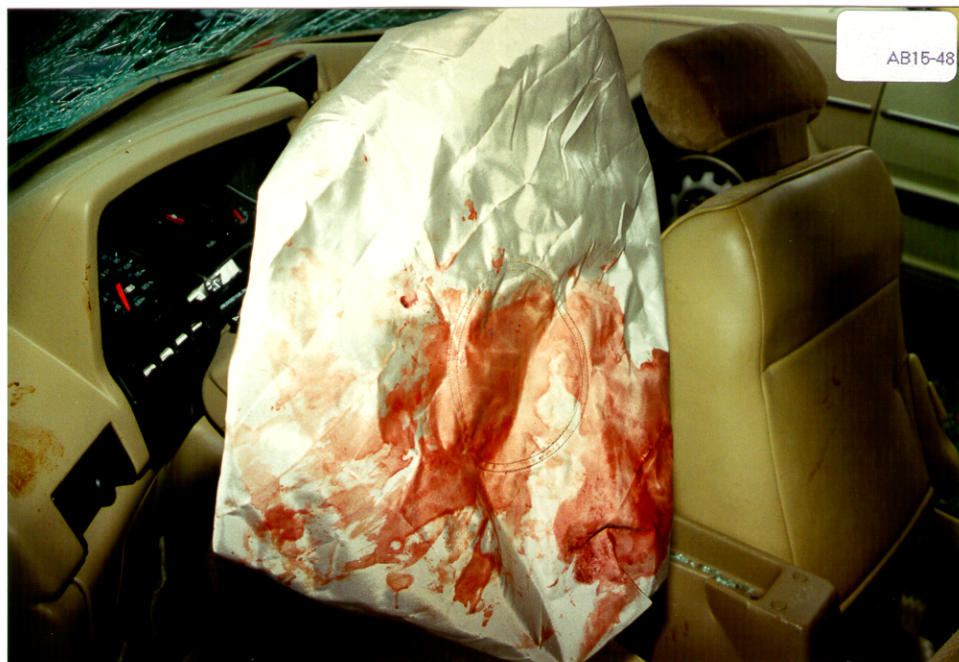
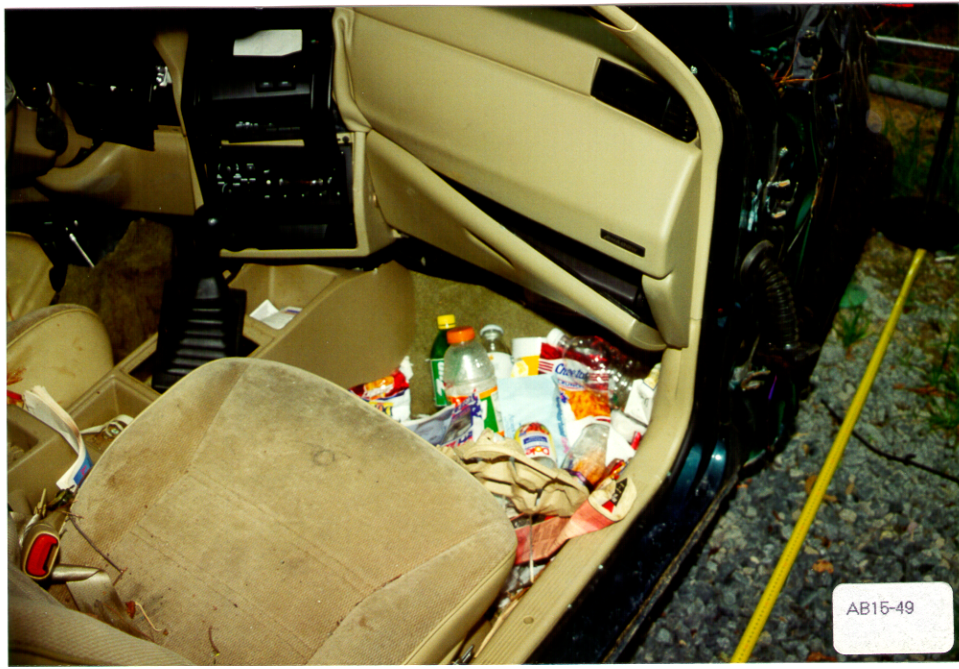
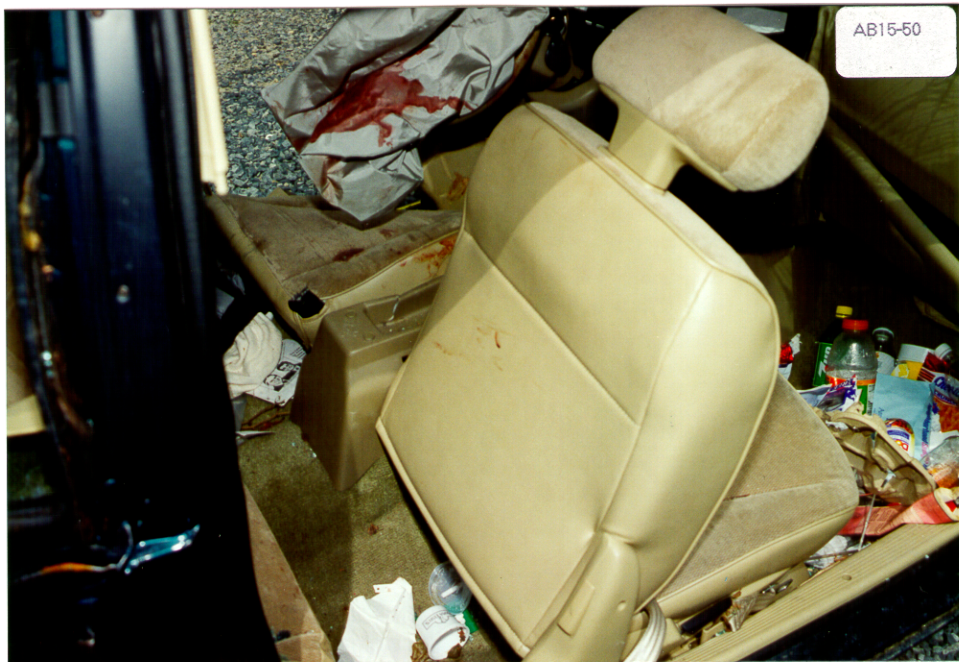
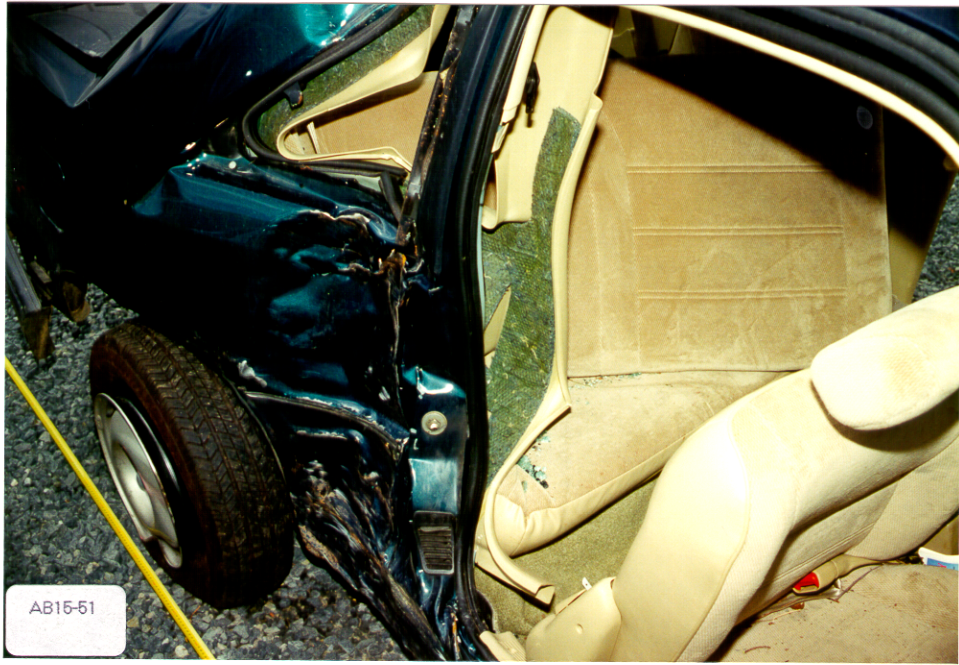
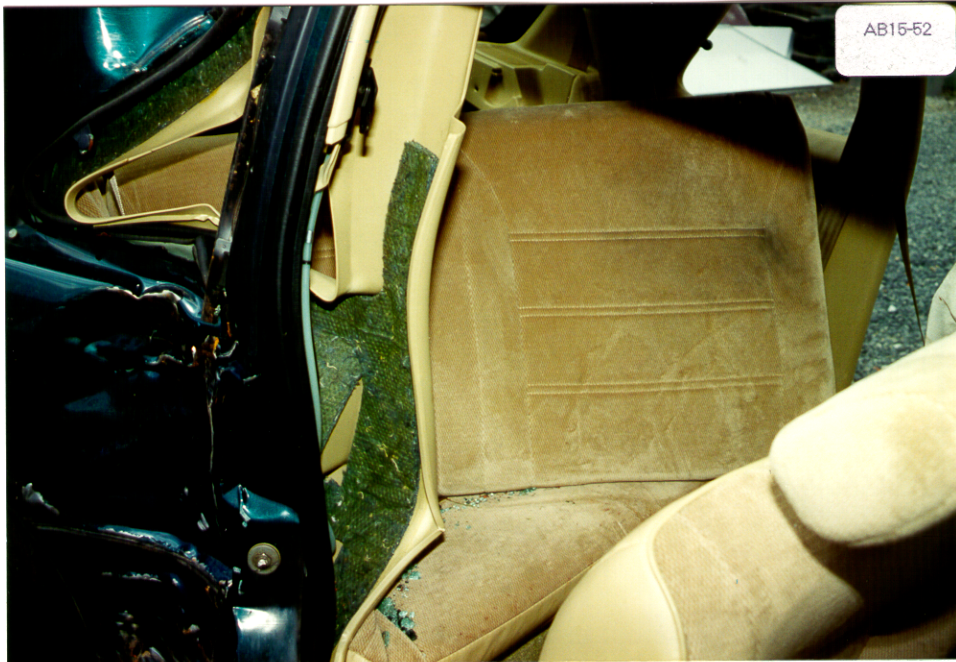
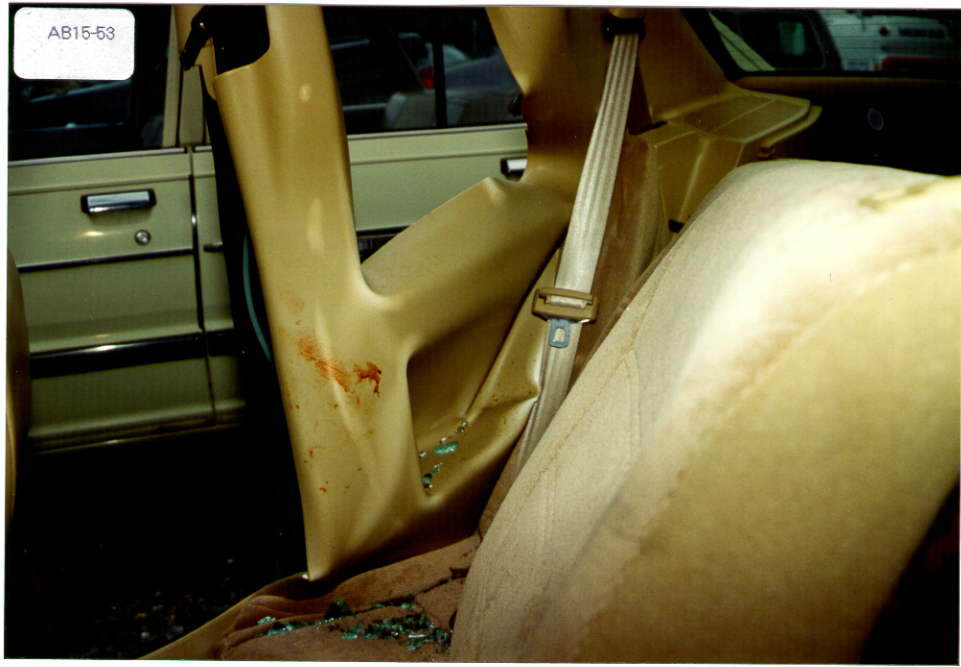
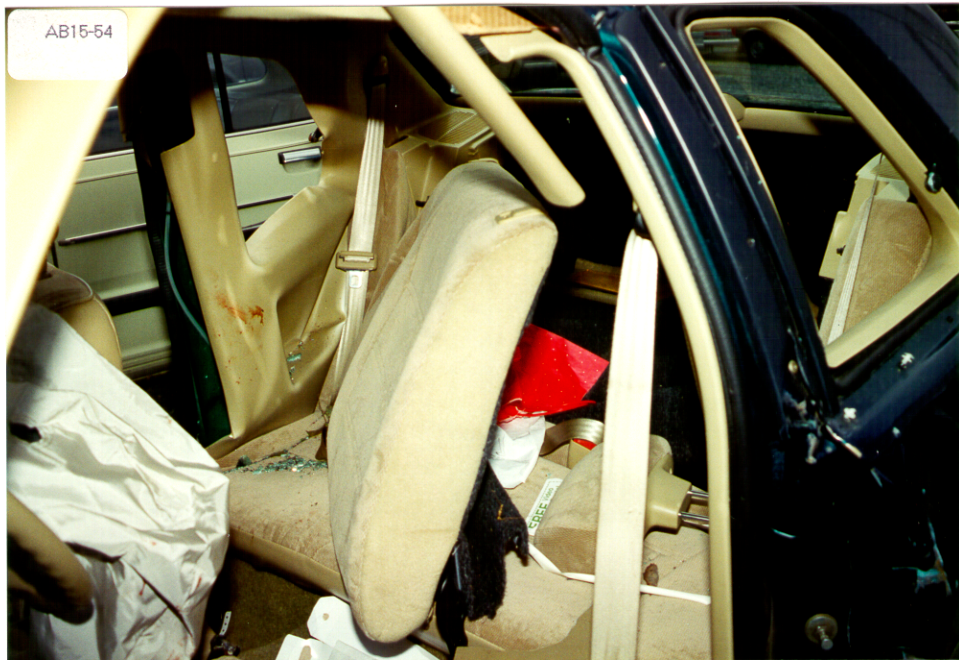
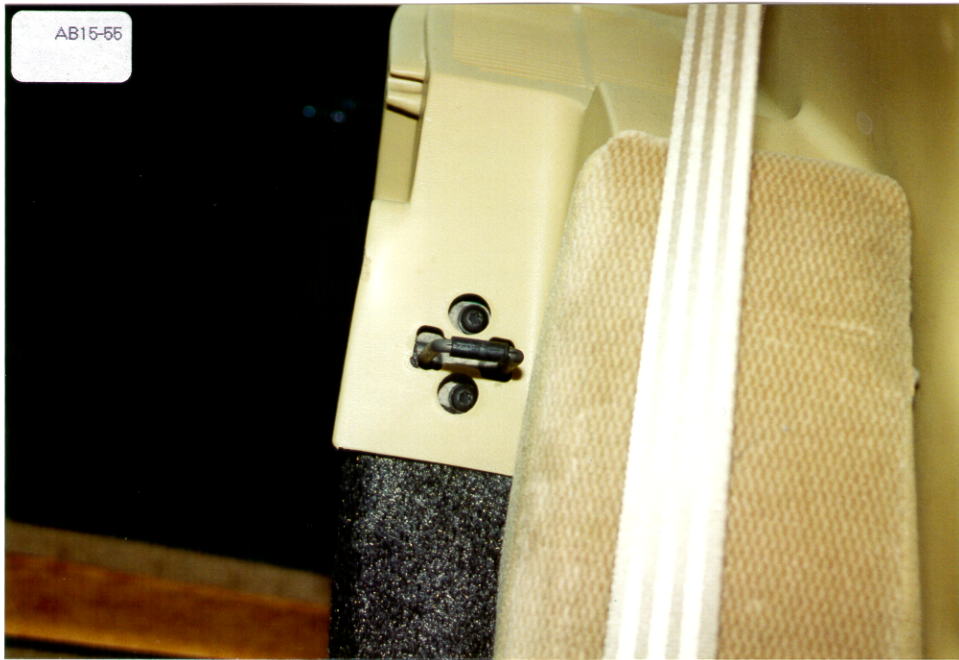
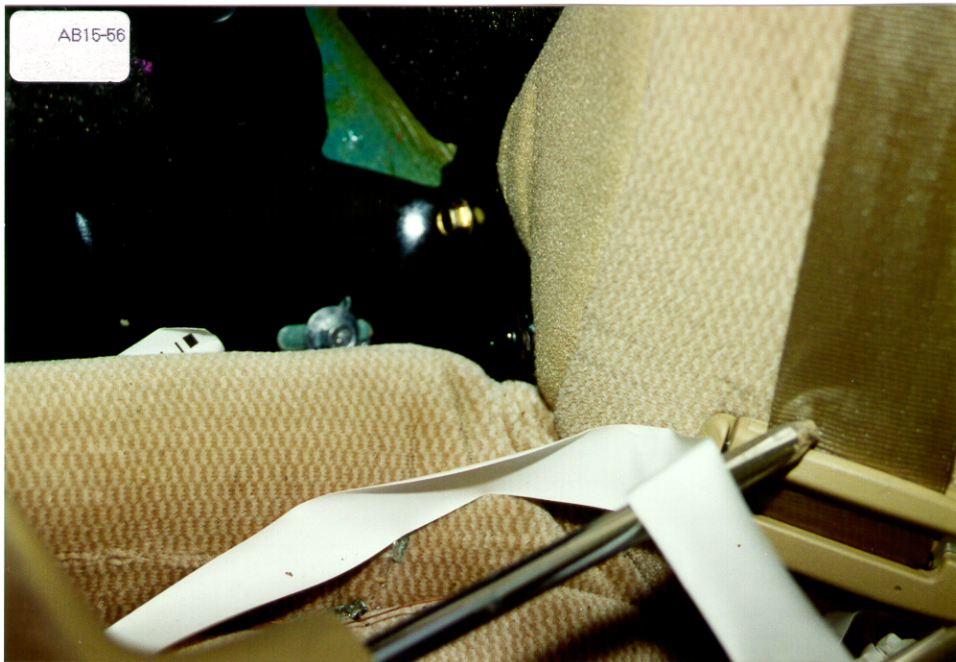
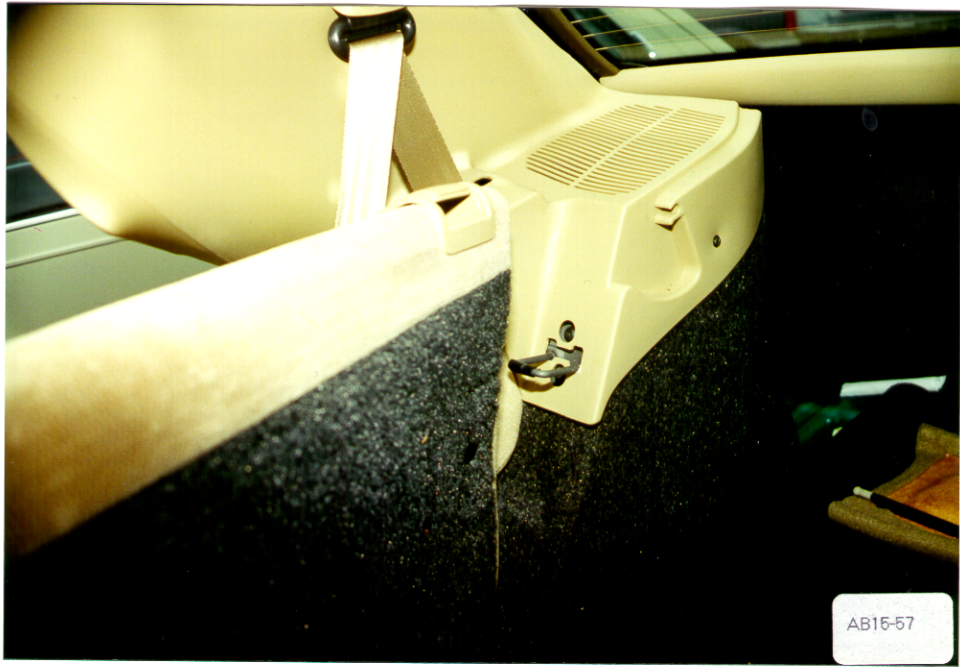
SLIDE NO.	VEHICLE NO.	ORIENTATION	SUBJECT MATTER
1	Vehicle 1	NW	Approach path, Vehicle 1
2-12	Vehicle 1	SE	Travel path, Vehicle 1 Slide 2 - R/F wheel departs roadway Slide 3 - L/F wheel departs roadway Slide 4 - R/F wheel crosses ditch Slide 5 - L/F wheel crosses ditch Slide 7 - POI 1, front plane with double guy wires Slide 11 & 12 - POI 4 & 5, L/F and R. side plane
13-14		SE	POI 6 and FRP
15-17	Vehicle 1	NW	Reverse travel path
18-30	Vehicle 1	CCW	Exterior views Slide 28 - Exterior, R/F door and L/F seat back rest damage from rear seat fold down back rest
31-52	Vehicle 1	---	Interior views Slides 40 - L/F door panel and front bumper beam Slide 45 & 46 - R/R intrusion Slide 49 & 51 - L/R seat back rest latch and fold down pivot Slide 52 - R/R seat back rest latch

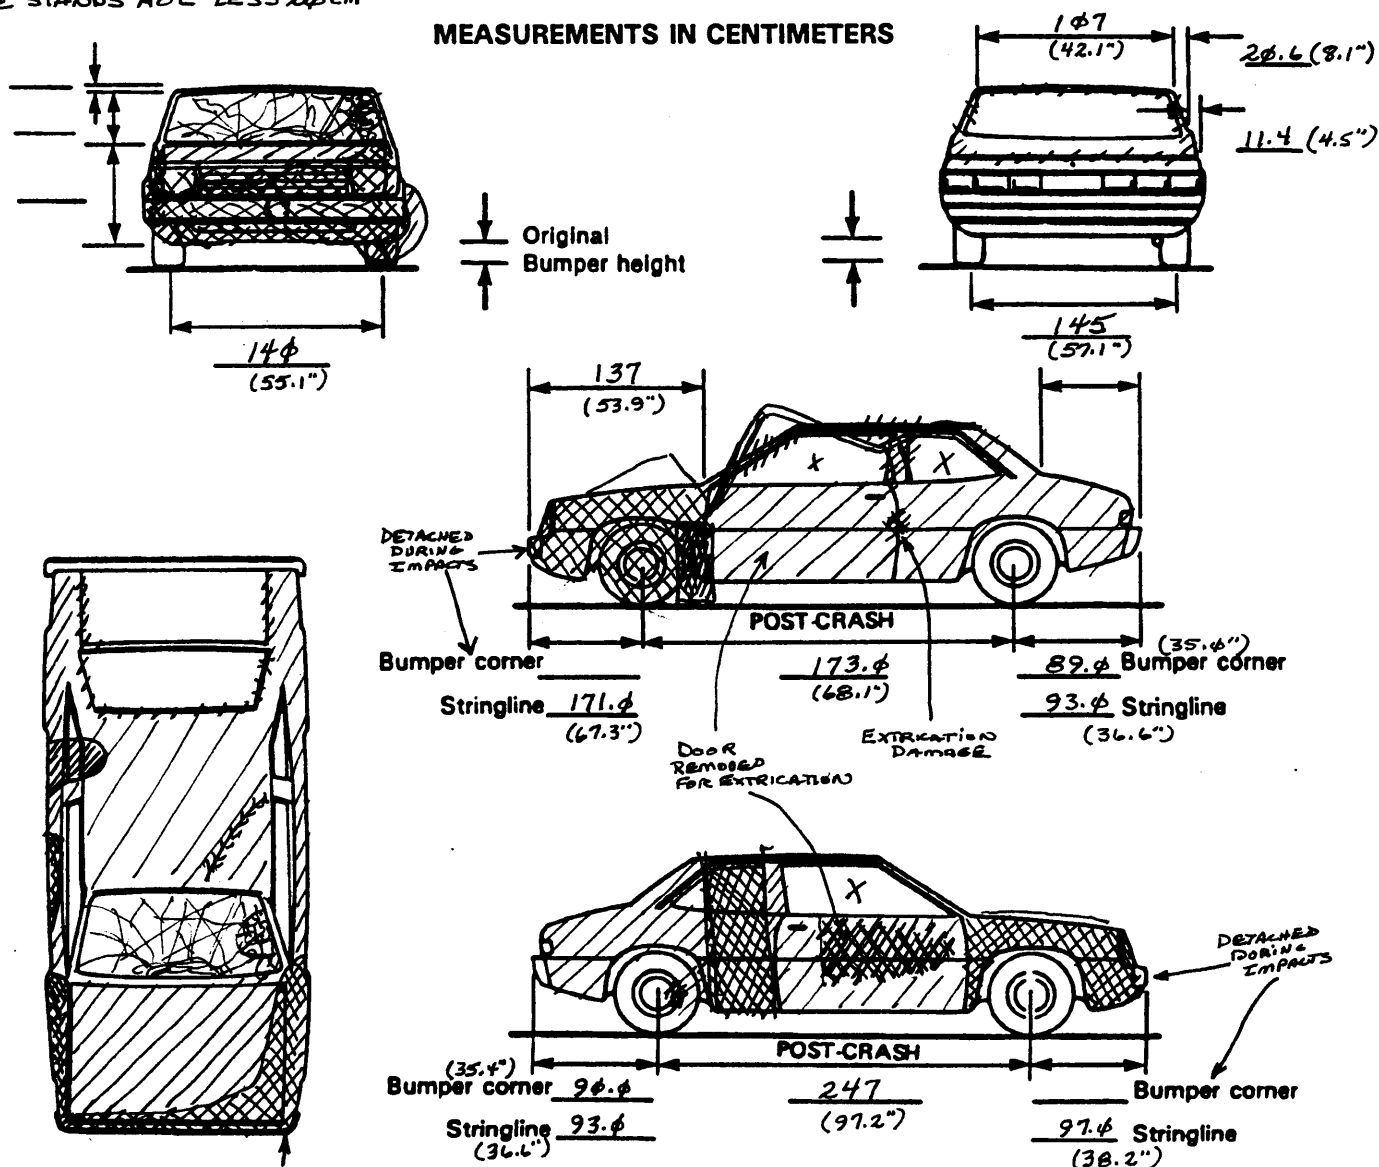
## VEHICLE DAMAGE SKETCH

GAUGE STANDS AOL LESS 20 cm

## MEASUREMENTS IN CENTIMETERS

Specific Impact Number	Plane of Impact C-Measurements	Direct Damage		Field L	C <sub>1</sub>	C <sub>2</sub>	C <sub>3</sub>	C <sub>4</sub>	C <sub>5</sub>	C <sub>6</sub>	±D
		Width (CDC)	Max Crush								
04	LOWER RADIATOR SUPPORT	58.7	131.5	146.5	131.5	52.1	26.5	21.3	17.2	16.3	-46.9

Specific Impact No.	Location of Direct Damage	Location of Field L
<u>04</u>	<u>BEGINS LEFT FRONT BUMPER CORNER</u>	<u>FULL FRONTAL</u>
<u>05</u>	<u>BEGINS 148.2cm (58.3in) REARWARD OF R/F AXLE</u>	<u>NOT MEASURED - CDC ONLY</u>
<u>06</u>	<u>R/F BUMPER - NO RESIDUAL DEFORMATION</u>	<u>NOT MEASURED - CDC ONLY</u>

Specific Impact Number	Plane of Impact C-Measurements	Direct Damage		Field L	C <sub>1</sub>	C <sub>2</sub>	C <sub>3</sub>	C <sub>4</sub>	C <sub>5</sub>	C <sub>6</sub>	±D
		Width (CDC)	Max Crush								
<u>01</u>	<u>FRONT BUMPER</u>	<u>5.1</u>	<u>&lt; 2.5</u>	<u>NOT MEASURED - CDC ONLY - ZONE 1</u>							
<u>02</u>	<u>MAX. EXTENSION R/F FENDER</u>	<u>140</u>	<u>33.5</u>	<u>NOT MEASURED - CDC ONLY - ZONE 2</u>							
<u>03</u>	<u>MAX. EXTENSION R/F DOOR</u>	<u>68</u>	<u>11.4</u>	<u>NOT MEASURED - CDC ONLY - ZONE 1</u>							
<u>05</u>	<u>MAX. EXTENSION R. SIDE</u>	<u>54</u>	<u>28.5</u>	<u>NOT MEASURED - CDC ONLY - ZONE 3</u>							
<u>06</u>	<u>FRONT BUMPER</u>	<u>N/A</u>	<u>0</u>	<u>NOT MEASURED - NO RESIDUAL DEFORMATION - CDC ONLY</u>							
				<u>U.S. EQUIVALENTS</u>							
<u>01</u>	<u>FRONT BUMPER</u>	<u>2.4"</u>	<u>&lt; 1.4"</u>				<u>CDC ONLY - ZONE 1</u>				
<u>02</u>	<u>MAX. EXTENSION R/F FENDER</u>	<u>55.1"</u>	<u>13.2"</u>				<u>CDC ONLY - ZONE 2</u>

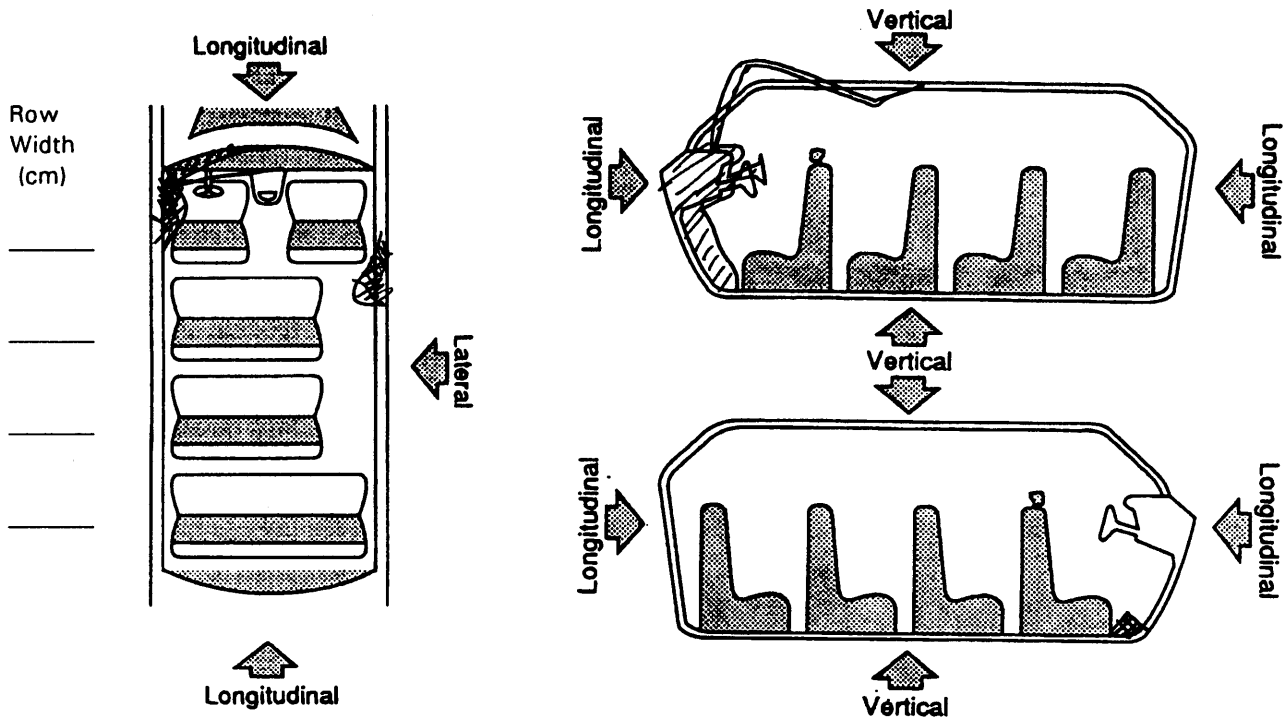
# INTRUSION WORKSHEET

LOCATION OF INTRUSION	INTRUDED COMPONENT	(All Measurements Are In Centimeters)			DOMINANT CRUSH DIRECTION
		COMPARISON VALUE	INTRUDED VALUE	INTRUSION	
11	TOE PAN	140.6 (55.4")	108.2 (42.6")	32.4 (12.8")	LONG.
23	"B" PILLAR (UPPER)	66.1 (26.0")	40.8 (16.1")	25.3 (10.0")	LATERAL
11	FLOOR/SILL	66.1 (26.0")	45.8 (18.0")	20.3 (8.0")	LATERAL
11	"A" PILLAR	80.6 (31.7")	65.6 (25.8")	15.0 (5.9")	LONG.
13	FLOOR	15.7 (6.2")	6.1 (2.4")	9.6 (3.8")	VERTICAL
11	L. INST. PANEL	30.0 (11.8")	-10 (-3.9")	40.0 (15.7")	LONG
11	L. INST. PANEL	57.0 (22.5")	70.0 (27.6")	13.0 (5.1")	VERTICAL
		-	-	=	
		-	-	=	
		-	-	=	
		-	-	=	
		-	-	=	
		-	-	=	
		-	-	=	
		-	-	=	
		-	-	=

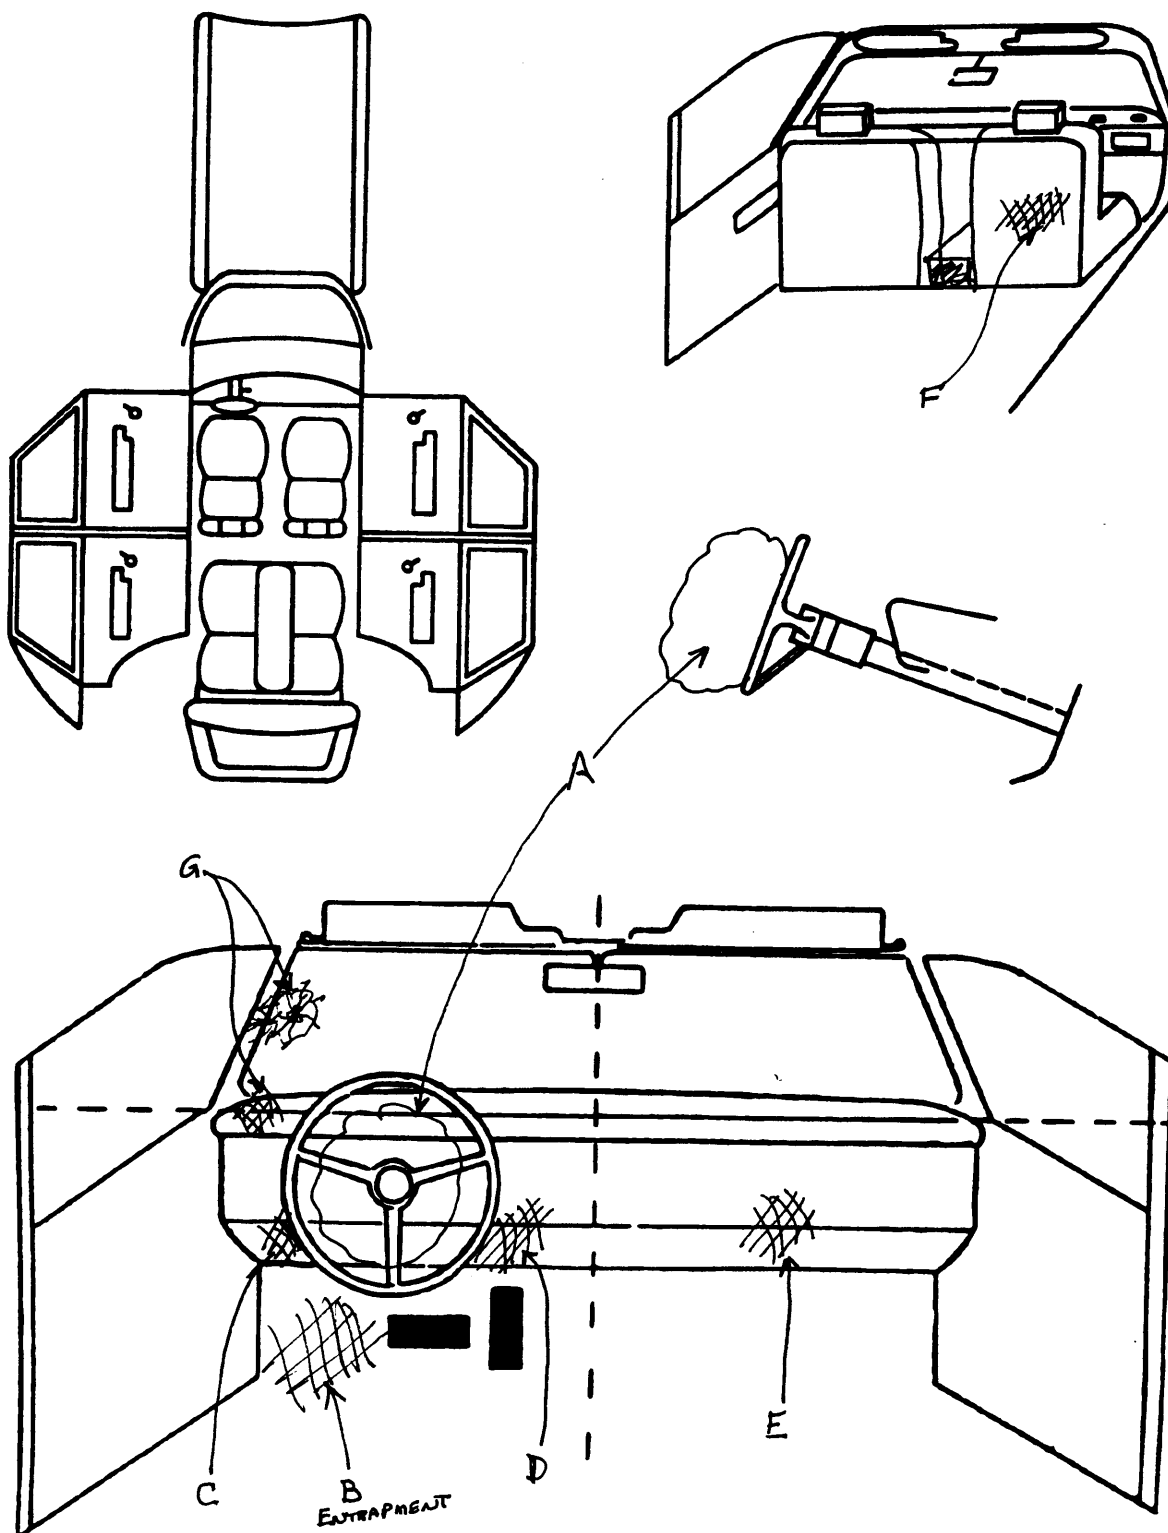
## VEHICLE INTERIOR SKETCHES

Note area of ejection/entrapment

As his lower extremities moved forward and upward, his left knee impacted the intruding left instrument panel while his left and right feet were being projected rearward by the intruding floor/toe pan. These movements resulted in an open fracture of the left femur shaft, a laceration of the left thigh and contusions of the lower left leg as his left leg contacted the instrument panel. He also sustained a fracture of the left medial malleolus as his left and right foot became entrapped by the floor/toe pan and the front edge of the left front seat cushion.

The driver's movement to the left and forward during the clockwise rotation was intensified as the rear seat back rest loaded, and forced forward the left front seat back rest. The rotation and seat back loading caused the driver to be projected into the intruded left "A" pillar and windshield. During the right, then left, movements of the driver and the subsequent interior contacts, he sustained a closed head injury with diffuse axonal injury (shearing), a bilateral contusion of the cerebrum, an open fracture of the left subcondylar mandible, a temporomandibular joint dislocation, left lateral and medial maxillary sinus wall fracture and a 4 cm laceration of the chin that extended into the mouth. In addition, the driver sustained a contusion of the left elbow as it contacted the interior surface of the left front door during this movement.
